## **Scope of Work NDCT Erosion on river Liddel**

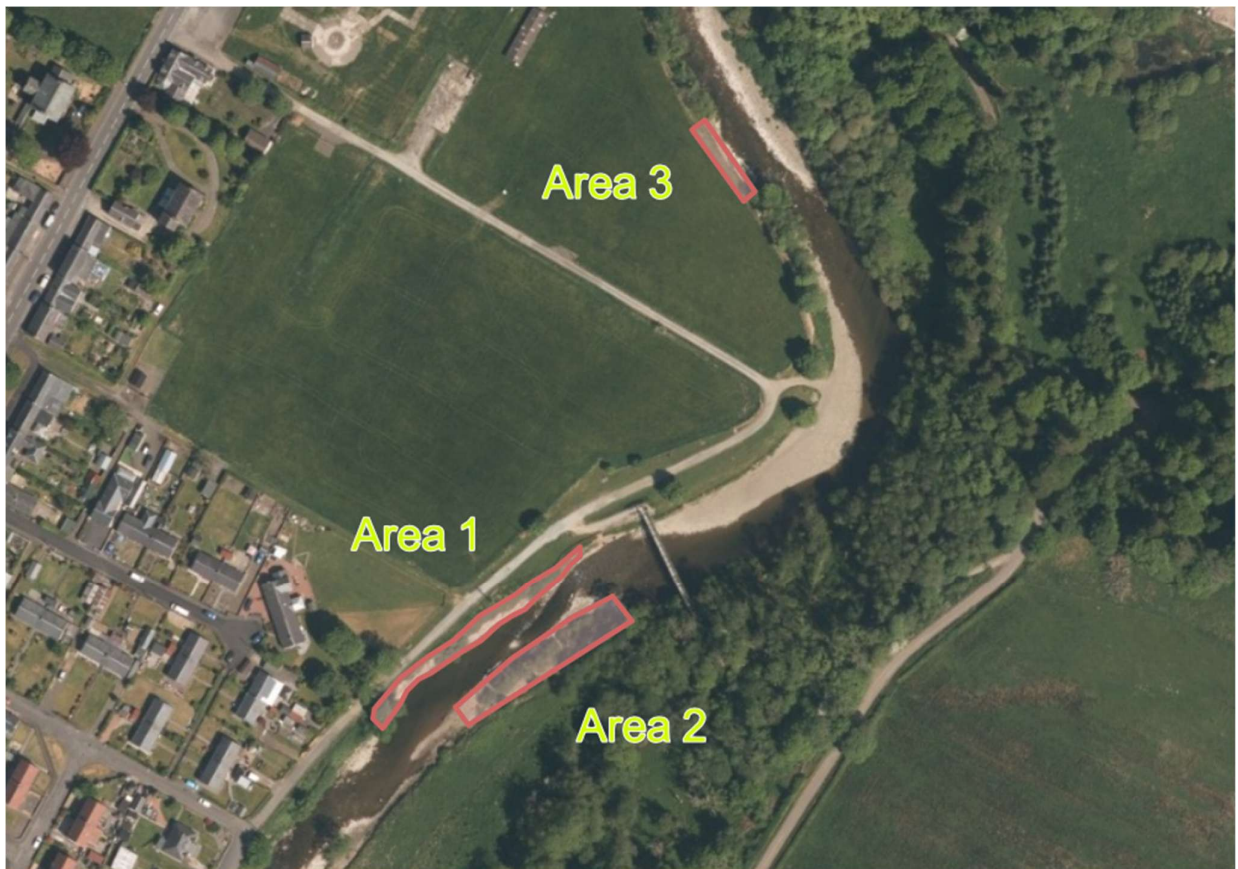
Area1 & Area 2 – coordinates 348668 587740

Badly damaged river banking (right bank) caused by excessive gravel and vegetation buildup on the left bank diverting river flow perpendicular across the river

Area 1 is approximately 96m long from the rip rap at the upstream end protecting the bridge abutment to a tree rooted in the banking at the downstream end. The banking appears to be made ground with various pieces of rubbish, excavated material making up the banking. The banking is now a meter or so from the public right of way with the Scottish Power HV cable already having been diverted. The banking is now eroding frequently with every spate of water and the trust need to address this before it takes out the road and starts to impact on the private ground on the other side of the road.

The banking is sitting on bedrock which is now exposed and can be clearly seen in normal river conditions. Given the space available and to limit the excavation required a rockbag solution is probably the best option here. Something like below finishing the upper section of the banking off with a new natural riverbank. NDCT is seeking some further design advice from the supplier but given the presence of bedrock these could be quite easily deployed onto the bedrock and laid accordingly thereafter to the desired height, something like below.
