## **Scope of Work NDCT Erosion on river Liddel**

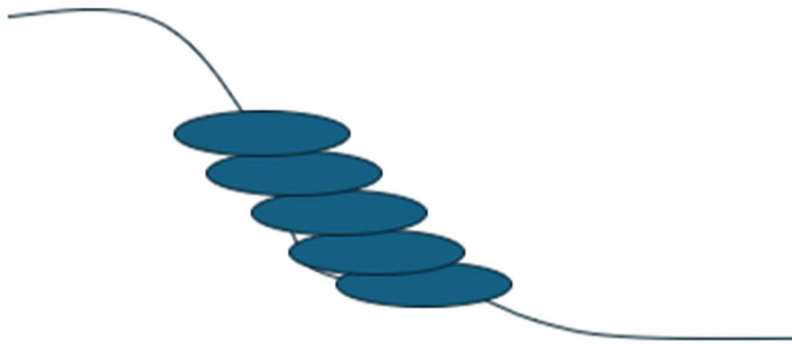
Area 1 is approximately 96m long from the rip rap at the upstream end protecting the bridge abutment to a tree rooted in the banking at the downstream end. The banking appears to be made ground with various pieces of rubbish, excavated material making up the banking. The banking is now a meter or so from the public right of way with the Scottish Power HV cable already having been diverted. The banking is now eroding frequently with every spate of water and the trust need to address this before it takes out the road and starts to impact on the private ground on the other side of the road.

The banking is sitting on bedrock which is now exposed and can be clearly seen in normal river conditions. Given the space available and to limit the excavation required a rockbag solution is probably the best option here. Something like below finishing the upper section of the banking off with a new natural riverbank. NDCT is seeking some further design advice from the supplier but given the presence of bedrock these could be quite easily deployed onto the bedrock and laid accordingly thereafter to the desired height, something like below.
